BOA Architecture / Government Services
Rancho Palos Verdes ADA Assessment

Facility Report with Photos - Programs Services

Facility ID: # 02B - City Hall Buildings

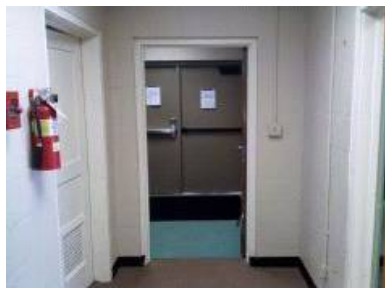
11.10B - Threshold - Height - The threshold at doorway exceeds 1/2" in height.
 Existing Condition: 3/4" high

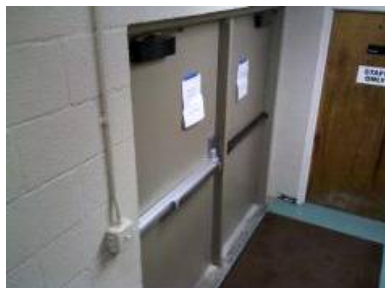
11.11 - Single-Action Hardware - Handles, locks, and latches or other operative devices are not operable with one hand and without tight grasping, pinching, or twisting of the wrist. (U-shaped handles, levers, and push/pull type mechanisms are acceptable designs.)
 Existing Condition:

067A - Replace Knob(s) with Lever Hardware - Remove knobs and existing latch and lock set. Provide new levers with new latch and lock sets.
 Additional Comments:

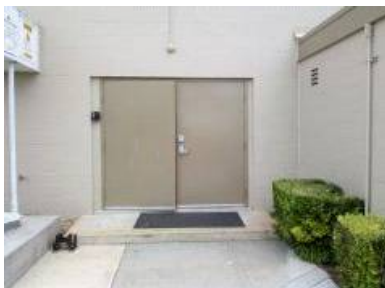
Photo #
471

Existing Condition: 65 3/4" high Security Pad.

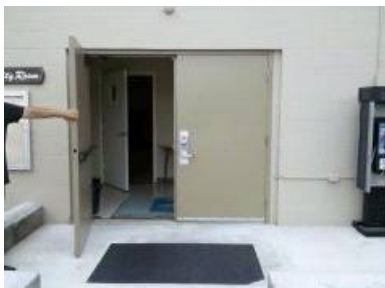
Photo #
472

Existing Condition: Floor Mat

075B - Surface-Mounted Walk-Off Mat - Remove existing walk-off mat and replace with new surface-mounted walk-off mat. Permanently attach mat to floor. Edges of mat shall be beveled with a slope no greater than 1:2 or shall not exceed 1/4" in height.

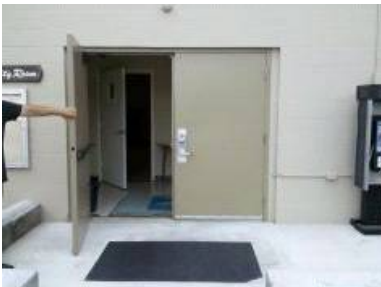
Location: Admin. - S. Stairwell Exit Doors
Photo # 472

Existing Condition: 78 1/4" at door

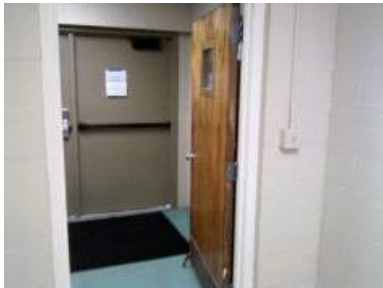
10.11B - Hardware Operating Effort - The force required to activate handles, pulls, latches, locks, and other operable parts of door exceeds 5 lbs.

Existing Condition: 8 Lb. x 2

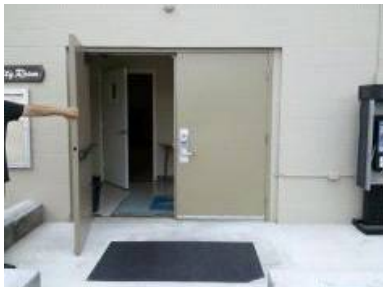
10.13A - Required Exit Door Sign - At grade level exterior exit door, there is no tactile and CA Braille exit sign with the word "EXIT" mounted on the wall adjacent to the latch side of the door.

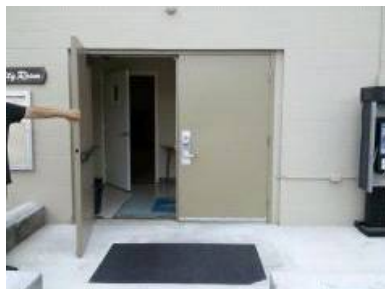
11.12 - Hardware Mounting Height - Mounting height of all operating hardware is not 30" min.. or 44" max., as measured to the highest operable part. (1994 ADA Standards permit a max.. height of 48"; CBC Standards permit a range of 30" min.. to 44" max..)

Existing Condition: 47" high push pad

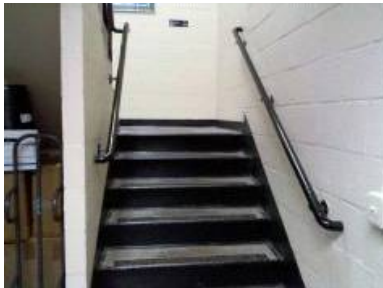
08.09A - Handrail Extensions - Top Landing - At ends of handrails, less than 12" of handrail extends beyond the top nosing. (Top and bottom handrail extensions are important safety features for persons with balance problems and must extend in the direction of the stair run to permit the intended use.) (Per ADA/CBC Standards, in existing buildings and facilities, full extension of handrails at stairs shall not be required in alterations where such extensions would be hazardous or impossible due to plan configuration.)

Existing Condition: None provided

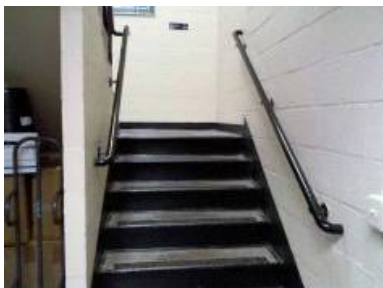
08.10B - Clearance - The clear space between handrails and walls is not 1-1/2" absolute. (ADA/CBC Standards apply an absolute dimension of 1-1/2", which provides knuckle clearance while generally disallowing entrapment of the forearm or elbow.)

Existing Condition: 2 1/8" clr

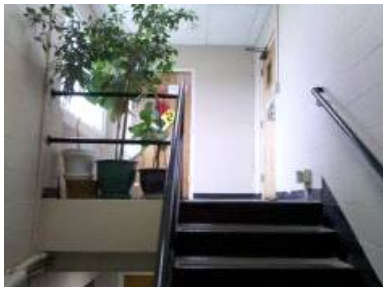
Photo #
488

Existing Condition: 29 1/2" high

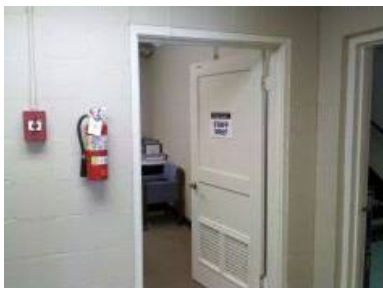
11.15A - Kick Plate - Bottom 10" of door does not have a smooth, uninterrupted surface on the push side to allow the door to be opened by a wheelchair footrest without creating a trap or hazardous condition. (This requirement does not apply to automatic and sliding doors.)

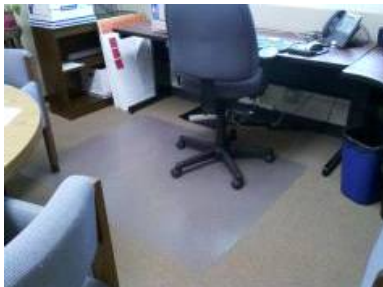
Location: Admin. Conference Rm.
Photo # 491

Existing Condition: Floor mat

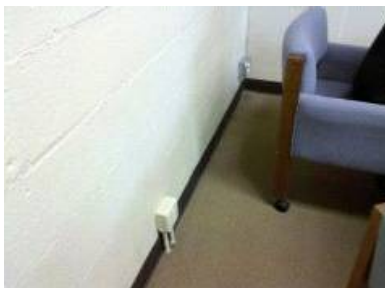
14.32A - Reach Range - Controls - Controls, dispensers, and similar devices are not between 9" and 54" AFF when the clear floor space allows a parallel approach. OR They are not between 15" and 48" AFF when the clear floor space allows only a forward approach.

Existing Condition: 4 outlets

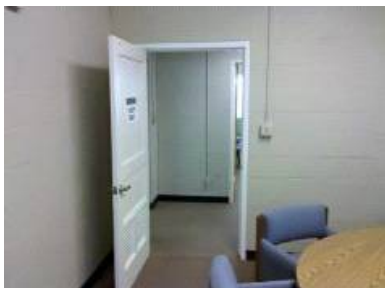
15B.19 - Assistive Listening Systems (ALS) - For assembly areas without fixed seats (e.g., conference or meeting rooms), a permanently installed assistive listening system or a portable assistive listening system, including an adequate number of electrical outlets or other supplementary wiring necessary to support a portable ALS, has not been provided. (A permanently installed ALS is required where (1) the assembly area accommodates 50 or more persons or has an audio-amplification system and (2) it has fixed seats.) (If portable assistive-listening systems are used for conference or meeting rooms, the system may serve more than one room.)

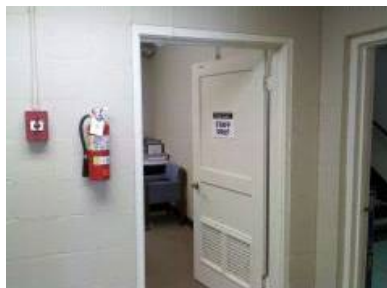
Photo #
490

11.17A - Recommendation: Providing Room/Space ID Sign - A sign designating the permanent room or space has not been provided.

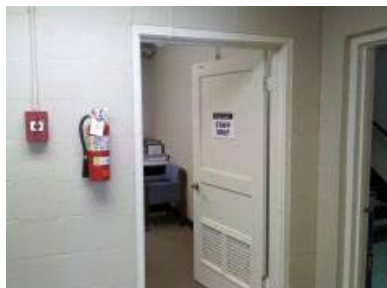
Photo #
490

Existing Condition: 77 1/2" at door

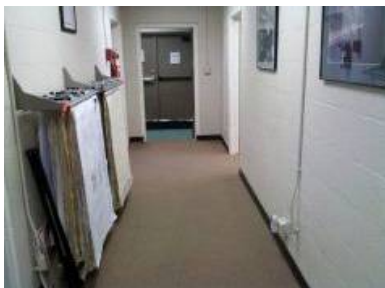
Photo #
496

Existing Condition: 11 1/4" at 47 1/2" high Blueprint hanger

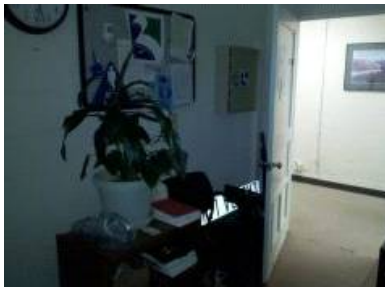
Photo #
497

Existing Condition: Thermostat twist type.

031B - Replace Control - Replace control. Repair/refinish as required.

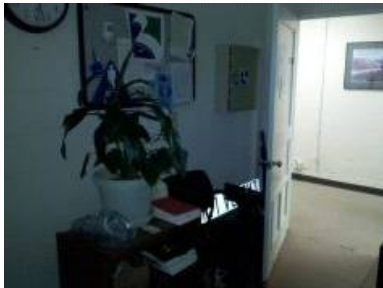
Photo #
497

Existing Condition: knob

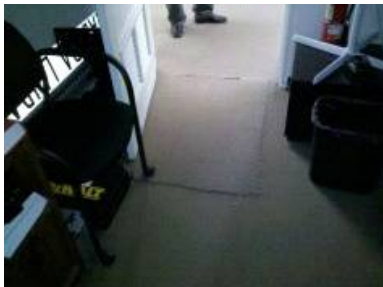
Photo #
501

Existing Condition: 3 floor mats

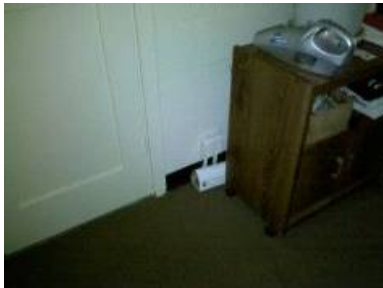
Photo #
502

Existing Condition: 3 outlets

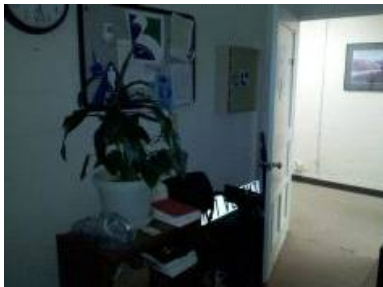
Photo #
497

Existing Condition: 53" high panel

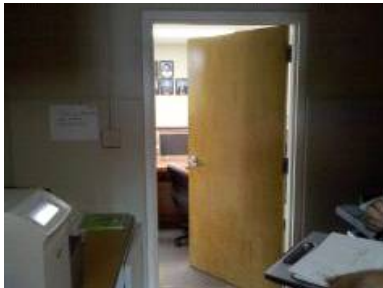
Photo #
504

Existing Condition: 77 1/2" at door

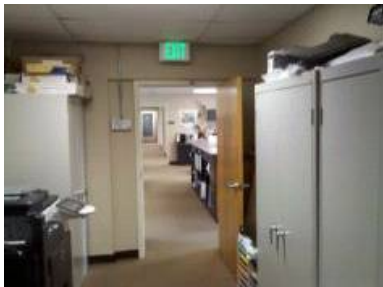
Photo #
354

Existing Condition: Door jamb at 77 1/2" AFF.

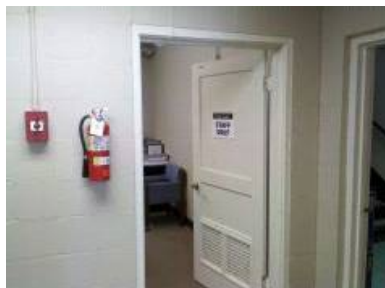
20.16B - Surface-Mounted Fire Extinguisher - Mounting Height - Where fire extinguishers are surface-mounted, mounting height of the extinguisher is not compliant. (Compliant surface-mounted extinguisher is 48" AFF maximum, as measured to the highest operable part, or in existing buildings, when the extinguisher is 54" AFF and parallel approach is provided)

Existing Condition: 61" high.

388D - Relocate Fire Extinguisher - Relocate existing fire extinguisher. Repair and refinish.

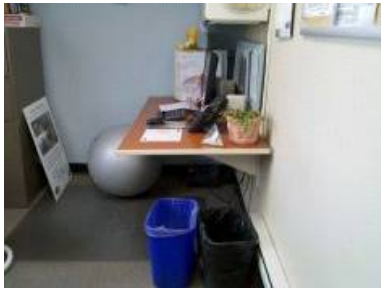
14.30A - Wall-Mounted Protruding Objects - Wall-mounted object(s) with leading edges between 27 and 80" from the floor project more than 4" into the pathway. (Wall mounted objects with leading edges at or below 27" may project any amount as long as the required clear width of an accessible route is not reduced.)

Existing Condition: Shelf-type desk protrudes 31" at 29 1/2" AFF.

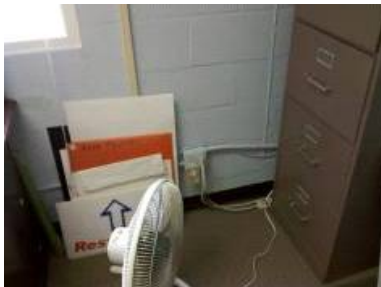
Location: Admin. - Office
Photo # 753

14.32A - Reach Range - Controls - Controls, dispensers, and similar devices are not between 9" and 54" AFF when the clear floor space allows a parallel approach. OR They are not between 15" and 48" AFF when the clear floor space allows only a forward approach.

Existing Condition: 1 power outlet at 13 1/2" AFF.

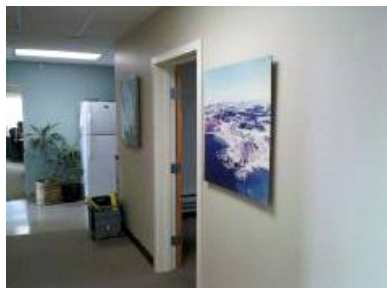
Location: Admin. - Conference Room
Photo # 756

Existing Condition: Door jamb at 77 1/2" AFF.

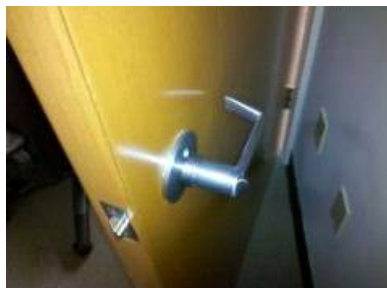
Location: Admin. - Conference Room
Photo # 757

Existing Condition: Twist-type locking mechanism.

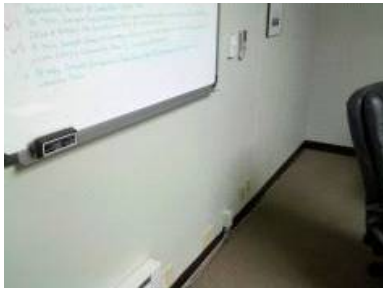
Location: Admin. - Conference Room
Photo # 758

Existing Condition: 1 power outlet, 2 data ports.

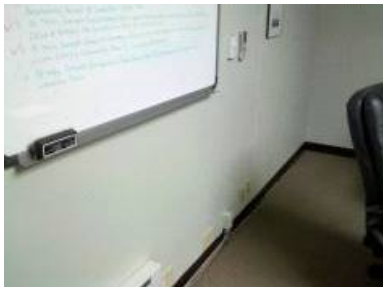
Location: Admin. - Conference Room
Photo # 758

Existing Condition: Twist-type thermostat.

031B - Replace Control - Replace control. Repair/refinish as required.

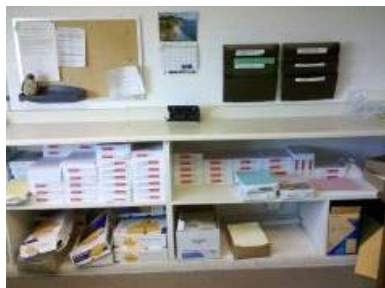
Location: Admin. - Copy Room
Photo # 763

Existing Condition: Counter top at 38" AFF.

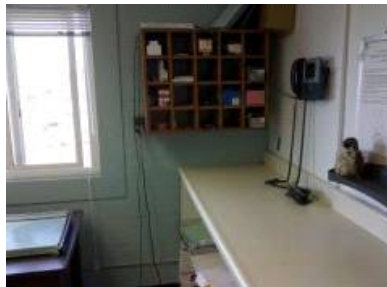
Photo #
647

14.32A - Reach Range - Controls - Controls, dispensers, and similar devices are not between 9" and 54" AFF when the clear floor space allows a parallel approach. OR They are not between 15" and 48" AFF when the clear floor space allows only a forward approach.

Existing Condition: Storage box at 67" AFF & mail bin at 60" AFF.

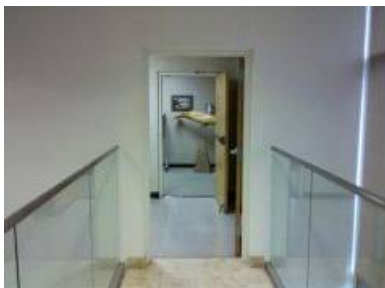
11.06A - Door Maneuvering Space - Door that is not automatic or power-assisted does not have compliant maneuvering space relative to the direction of approach as shown in CBC Fig. 11B-26. (Approach // Side // Width // Depth) (Front // Pull // D + 24" * // 60") (Front // Push // D + 0" ** // 48") (Latch // Pull // D + 24" // 60") (Latch // Push // D + 24" // 44" ***) (Hinge // Pull // D + 36" // 60") (Hinge // Push // 54" **** // 44" *****) (* D + 18" at interior doors.) (** D + 12" if door has both a latch and a closer.) (*** 48" if door has closer.) (**** Measured from latch toward hinge.) (***** 48" if door has both a latch and a closer.)

Existing Condition: 10" maneuvering space, guard rail.

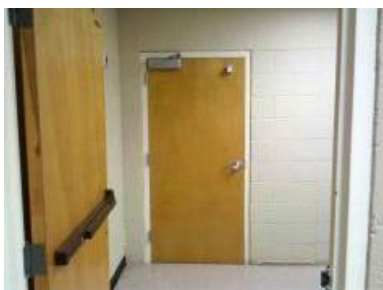
Location: Admin. - Elevator Platform
Photo # 521

Existing Condition: 10 LBF.

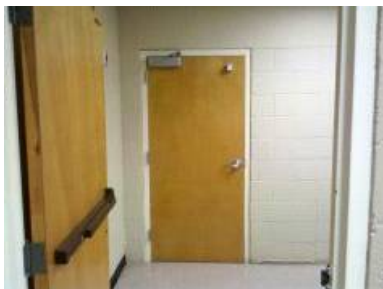
Location: Admin. - Elevator Platform
Photo # 521

Existing Condition: 1.8 second closer.

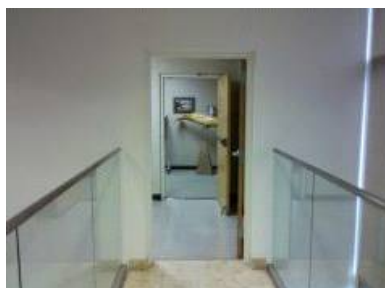
Location: Admin. - Elevator Platform
Photo # 520

Existing Condition: Door jamb at 78" AFF.

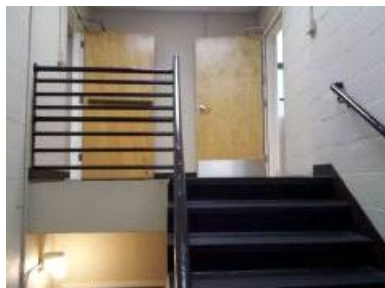
Location: Admin. - Elevator Platform
Photo # 369

Existing Condition: 22 1/2" between doors opening toward one another.

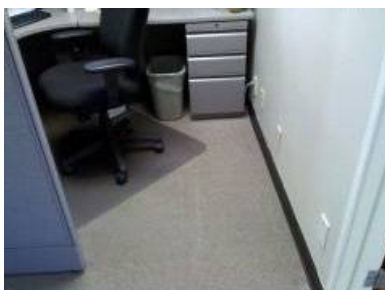
Photo #
525

Existing Condition: 4 power outlets and 7 data ports at less than 15" AFF.

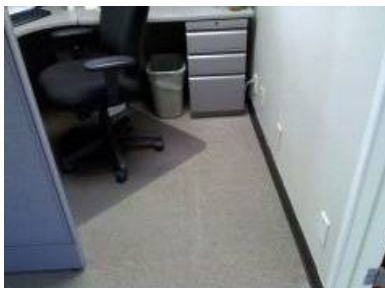
Photo #
525

Existing Condition: Floor mat.

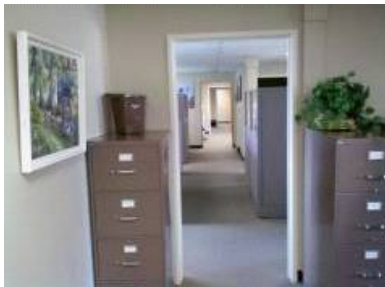
Photo #
528

Existing Condition: Door jamb at 79" AFF.

Additional Comments: Remove door jamb, patch and repair to match existing.

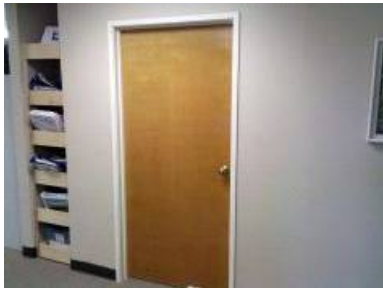
Photo #
529

Existing Condition: Door knob.

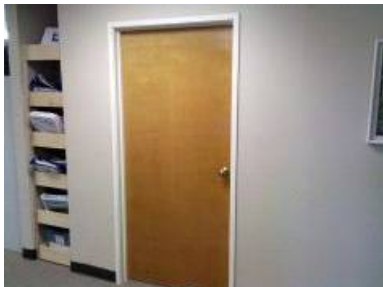
Photo #
529

Existing Condition: Door jamb at 79" AFF.

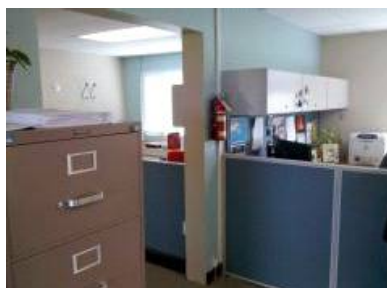
Photo #
531

Existing Condition: 60" AFF.

388D - Relocate Fire Extinguisher - Relocate existing fire extinguisher. Repair and refinish.

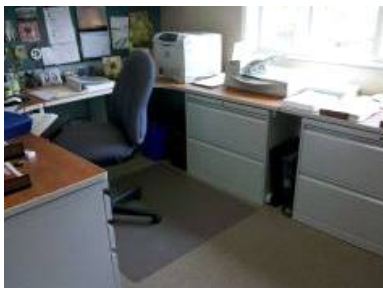
Photo #
533

Existing Condition: Floor mat.

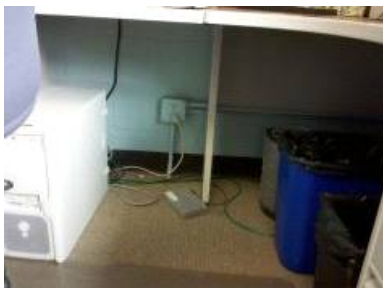
Photo #
534

Existing Condition: 5 power outlets at less than 15" AFF.

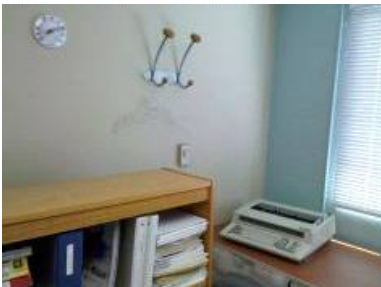
Photo #
535

Existing Condition: Coat hook above required reach range limit.

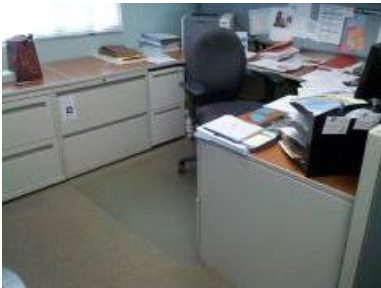
Photo #
537

Existing Condition: Floor mat.

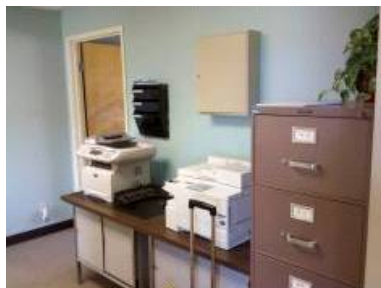
Admin. - Office

14.32A - Reach Range - Controls - Controls, dispensers, and similar devices are not between 9" and 54" AFF when the clear floor space allows a parallel approach. OR They are not between 15" and 48" AFF when the clear floor space allows only a forward approach.

Existing Condition: Key lock box at 64" AFF, mail box at 62" AFF.

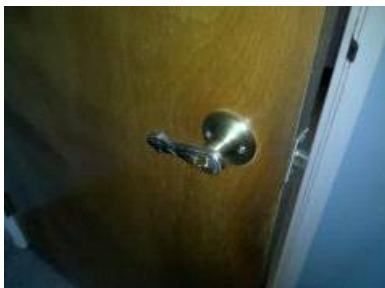
Photo #
546

Existing Condition: Twist-type locking mechanism.

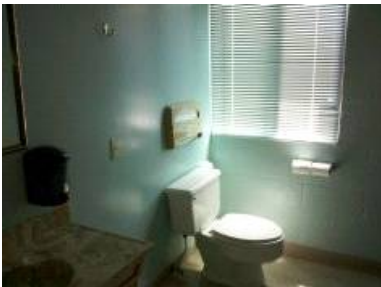
Location: Admin. - Men's Restroom
Photo # 550

Existing Condition: 19 3/4" from side wall.

319C - Water Closet - New Location - Replace existing water closet with compliant model in new location.

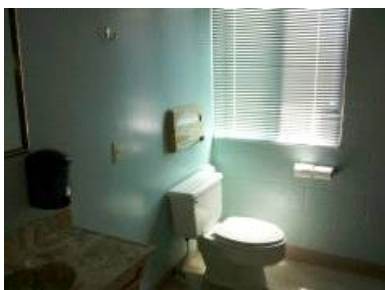
Location: Admin. - Men's Restroom
Photo # 550

Existing Condition: 15 1/2" AFF.

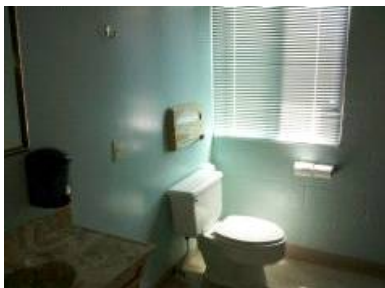
Location: Admin. - Men's Restroom
Photo # 550

Existing Condition: 46" AFF.

294C - Relocate Dispenser - Relocate existing dispenser on an accessible route. Patch and repair wall substrate and finishes, to match adjacent undisturbed surfaces.

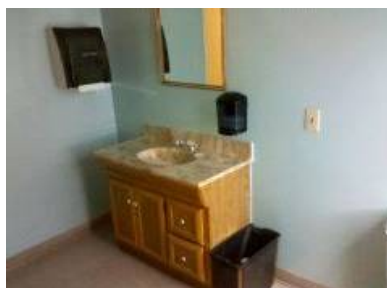
Photo #
555

Existing Condition: Knee space not provided.

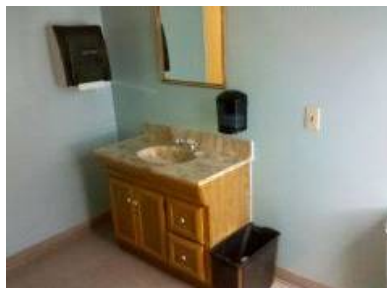
Photo #
555

Existing Condition: Twist-type faucet controls.

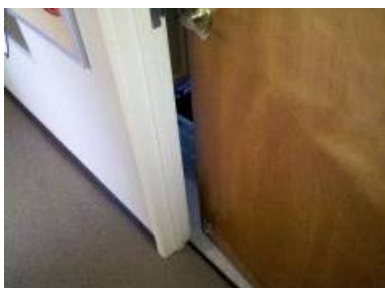
11.15A - Kick Plate - Bottom 10" of door does not have a smooth, uninterrupted surface on the push side to allow the door to be opened by a wheelchair footrest without creating a trap or hazardous condition. (This requirement does not apply to automatic and sliding doors.)

Existing Condition: Door stop.

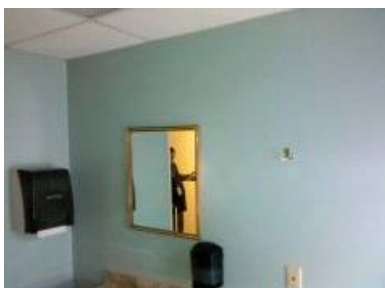
16.83 - Coat Hook - Height - Where a coat hook is provided in an accessible stall, height of coat hook exceeds 48" AFF.

Existing Condition: Coat hook at 65" AFF.

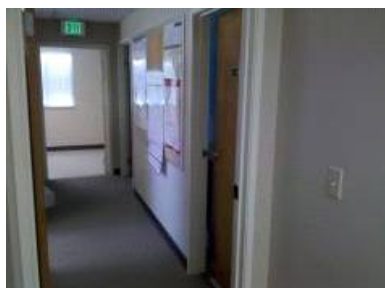
Photo #
547

Existing Condition: Door jamb at 79 1/2" AFF.

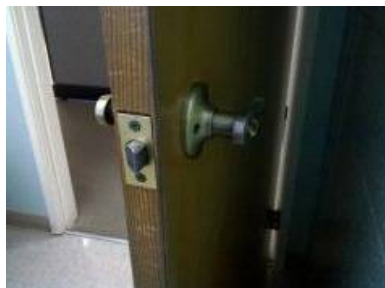
Photo #
562

Existing Condition: Twist-type locking mechanism.

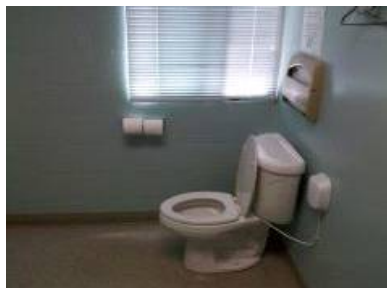
Location: Admin. - Women's Restroom
Photo # 566

Existing Condition: 19" from side wall.

319C - Water Closet - New Location - Replace existing water closet with compliant model in new location.

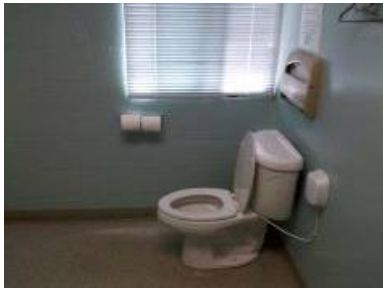
Location: Admin. - Women's Restroom
Photo # 566

16.48 - WC Seat Height - The top of the WC seat is not between 17" and 19" AFF. Existing Condition: 15 1/2" AFF.

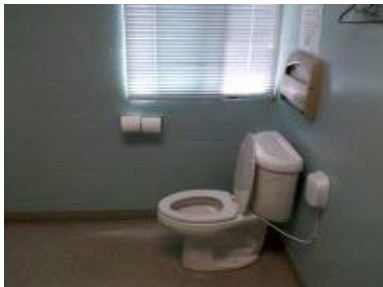
Location: Admin. - Women's Restroom
Photo # 566

16.53 - SC Dispenser Height - Mounting height of seat cover dispenser's highest operable part exceeds 40" AFF. Existing Condition: 46" AFF.

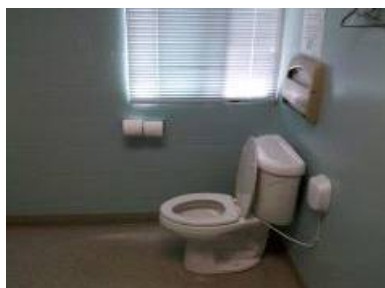
Location: Admin. - Women's Restroom
Photo # 566

Existing Condition: 39" from back wall.

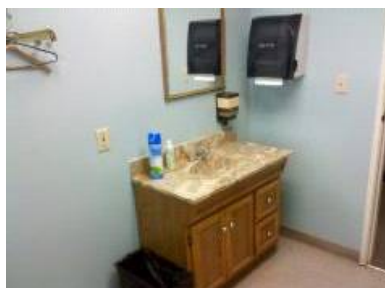
Location: Admin. - Women's Restroom
Photo # 572

Existing Condition: Knee space not provided.

300C - Replace Lavatory - Replace existing lavatory with new compliant model.

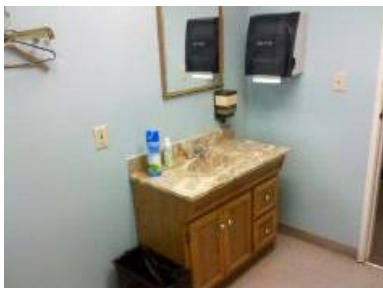
Location: Admin. - Women's Restroom
Photo # 572

Existing Condition: Twist-type faucet controls.

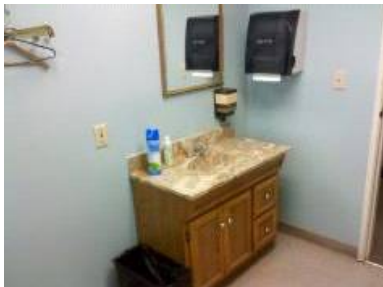
Location: Admin. - Women's Restroom
Photo # 572

Existing Condition: 46" AFF.

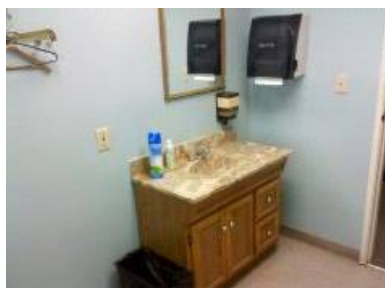
16.84A - Paper Towel Dispenser - Operating Height - Mounting height of paper towel dispenser's highest operable part exceeds 40" AFF. (Where provided, ADA Standards require at least one paper towel dispenser to be accessible with the highest operable part placed within at least one of the reach ranges specified in 4.2.5 and 4.2.6; where provided, CBC Standards require at least one paper towel dispenser to be accessible with the highest operable part no higher than 40" AFF.)

Existing Condition: 49" AFF.

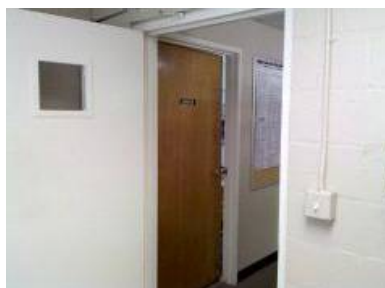
11.15A - Kick Plate - Bottom 10" of door does not have a smooth, uninterrupted surface on the push side to allow the door to be opened by a wheelchair footrest without creating a trap or hazardous condition. (This requirement does not apply to automatic and sliding doors.)

Existing Condition: Door stop.

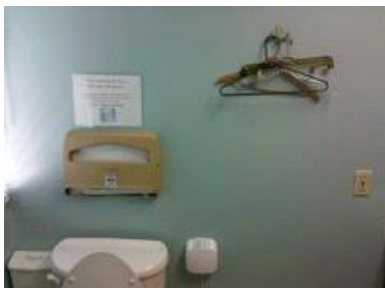
16.83 - Coat Hook - Height - Where a coat hook is provided In an accessible stall, height of coat hook exceeds 48" AFF.

Existing Condition: 65" AFF.

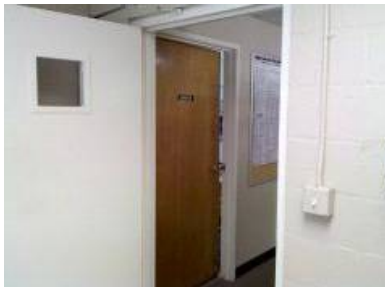
14.31 - Head Room - Clear head room is at less than 80" within the pedestrian circulation area, including the accessible route of travel.

Existing Condition: Door jamb at 79 1/2" AFF.

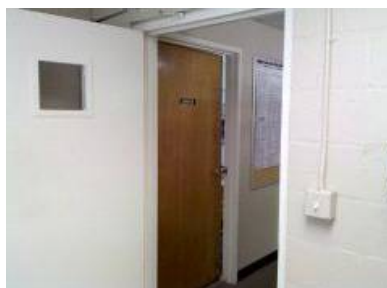
14.27 - > 1/2" Changes in Level - Ramps or elevators are not used for changes in level greater than 1/2". (Lifts may only be used in certain limited situations.)

Existing Condition: 1/2" change in level from carpet to vinyl flooring.

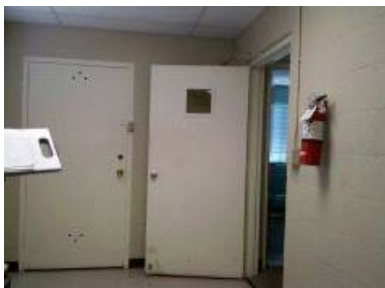
Photo #
581

Existing Condition: Door knob and lock.

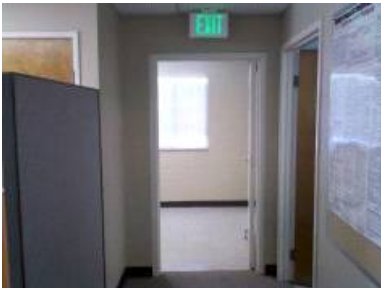
11.06A - Door Maneuvering Space - Door that is not automatic or power-assisted does not have compliant maneuvering space relative to the direction of approach as shown in CBC Fig. 11B-26. (Approach // Side // Width // Depth) (Front // Pull // D + 24" * // 60") (Front // Push // D + 0" ** // 48") (Latch // Pull // D + 24" // 60") (Latch // Push // D + 24" // 44" ***) (Hinge // Pull // D + 36" // 60") (Hinge // Push // 54" **** // 44" *****) (* D + 18" at interior doors.) (** D + 12" if door has both a latch and a closer.) (***) 48" if door has closer.) (**** Measured from latch toward hinge.) (***** 48" if door has both a latch and a closer.)

Existing Condition: 11 1/2" push side, wall.

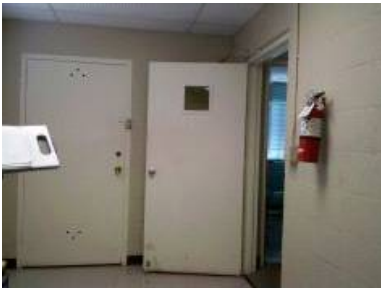
Location: Admin. - Stairwell
Photo # 581

Existing Condition: Door knob.

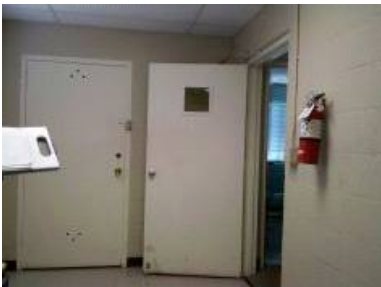
Location: Admin. - Stairwell
Photo # 581

11.15A - Kick Plate - Bottom 10" of door does not have a smooth, uninterrupted surface on the push side to allow the door to be opened by a wheelchair footrest without creating a trap or hazardous condition. (This requirement does not apply to automatic and sliding doors.)

Existing Condition: Door stop.

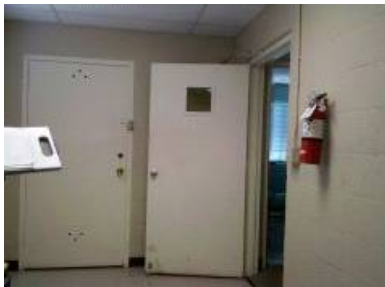
Location: Admin. - Stairwell
Photo # 581

Existing Condition: 6 LBF.

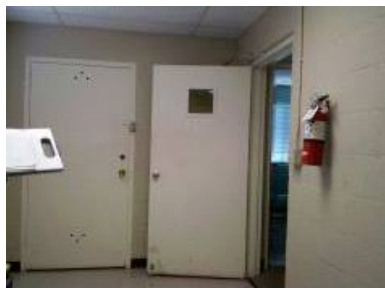
Keynote 587

Location: Admin. - Stairwell
Photo # 581

Existing Condition: 2.5 second closer.

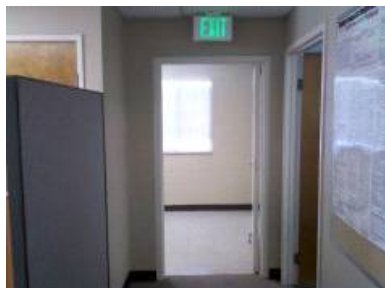
Keynote 588

Location: Admin. - Stairwell
Photo # 582

Existing Condition:

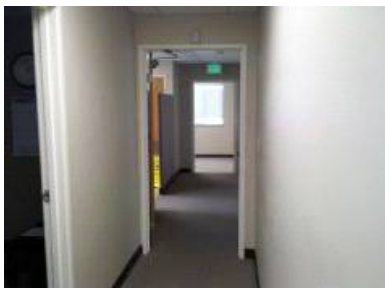
Keynote 590

11.06A - Door Maneuvering Space - Door that is not automatic or power-assisted does not have compliant maneuvering space relative to the direction of approach as shown in CBC Fig. 11B-26. (Approach // Side // Width // Depth) (Front // Pull // D + 24" * // 60") (Front // Push // D + 0" ** // 48") (Latch // Pull // D + 24" // 60") (Latch // Push // D + 24" // 44" ***) (Hinge // Pull // D + 36" // 60") (Hinge // Push // 54" **** // 44" *****) (* D + 18" at interior doors.) (** D + 12" if door has both a latch and a closer.) (***) 48" if door has closer.) (**** Measured from latch toward hinge.) (***** 48" if door has both a latch and a closer.)

Existing Condition: 5" at push and pull side.

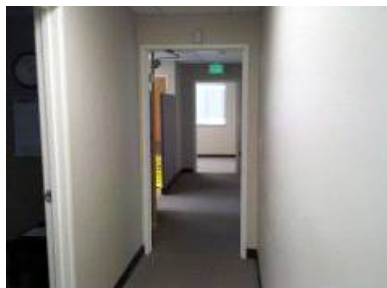
Keynote 591

Location:
Admin. - Hallway

Existing Condition: 6 LBF.

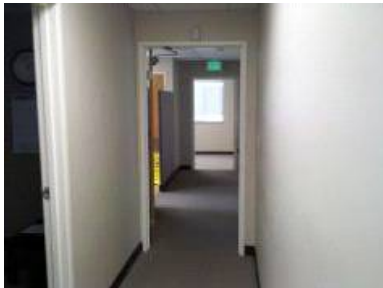
Keynote 593

Location:
Admin. - Hallway

Existing Condition: 7 LBF.

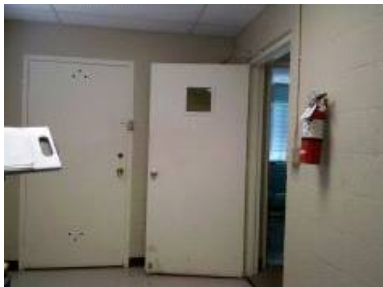
Keynote 594

Location:
Admin. - Stair Well

Existing Condition: 59" AFF.

388D - Relocate Fire Extinguisher - Relocate existing fire extinguisher. Repair and refinish.

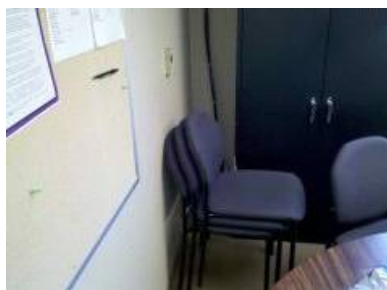
Keynote 599

Location: Admin. - Break Room
Photo # 596

Existing Condition: 2 power outlets, 1 data port at less than 15" AFF.

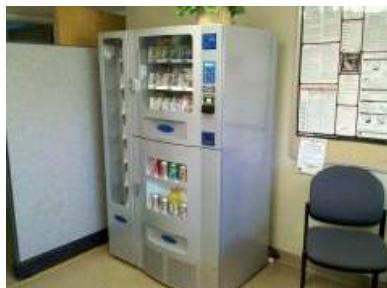
Keynote 600

Location: Admin. - Break Room
Photo # 600

Existing Condition: Vending machine coin slot at 67" AFF.

Additional Comments: Replace vending machine with new compliant model.

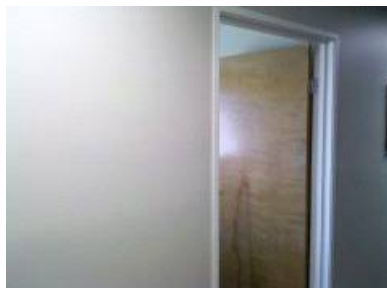
Keynote 601

14.31 - Head Room - Clear head room is at less than 80" within the pedestrian circulation area, including the accessible route of travel.

Existing Condition: Door jamb at 79 1/4" AFF.

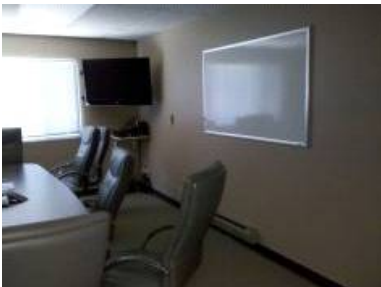
Keynote 604

Location: Admin. - Conference Room
Photo # 603

Existing Condition: Flat screen TV protrudes at 54" AFF.

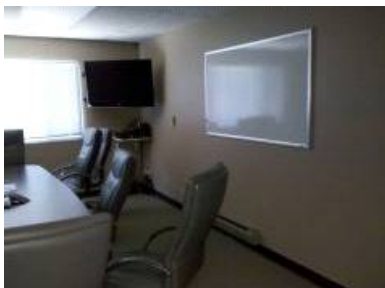
Keynote 605

15B.19 - Assistive Listening Systems (ALS) - For assembly areas without fixed seats (e.g., conference or meeting rooms), a permanently installed assistive listening system or a portable assistive listening system, including an adequate number of electrical outlets or other supplementary wiring necessary to support a portable ALS, has not been provided. (A permanently installed ALS is required where (1) the assembly area accommodates 50 or more persons or has an audio-amplification system and (2) it has fixed seats.) (If portable assistive-listening systems are used for conference or meeting rooms, the system may serve more than one room.)

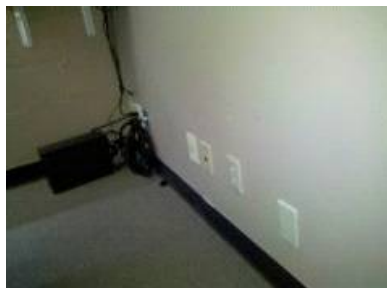
Keynote 606

14.32A - Reach Range - Controls - Controls, dispensers, and similar devices are not between 9" and 54" AFF when the clear floor space allows a parallel approach. OR They are not between 15" and 48" AFF when the clear floor space allows only a forward approach.

Existing Condition: 6 power outlets, 3 data ports.

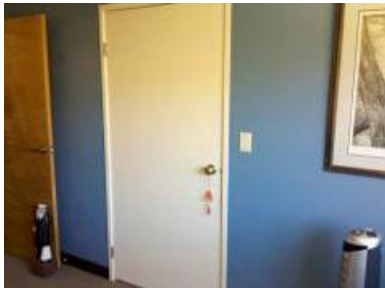
Keynote 612

Location:
Admin. - Office

Existing Condition: Door jamb at 79 1/4" AFF.

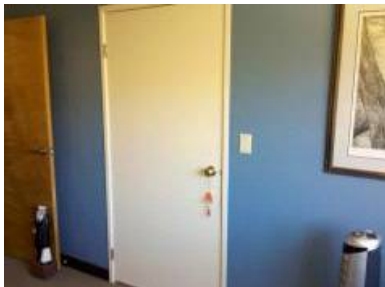
Keynote 613

Location:
Admin. - Office

Existing Condition: Door knob.

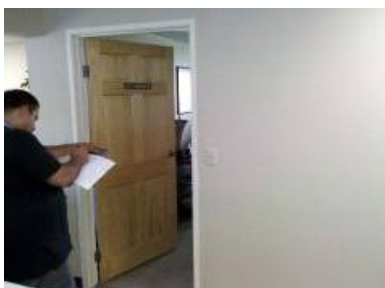
Keynote 614

Location:
Admin. - Office

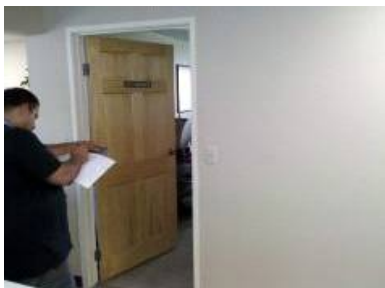
Keynote 615

Location:
Admin. - Office

Existing Condition: Mounted on door.

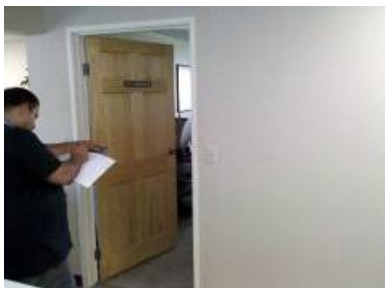
Keynote 616

Location:
Admin. - Office

Existing Condition: Door jamb at 79 5/8" AFF.

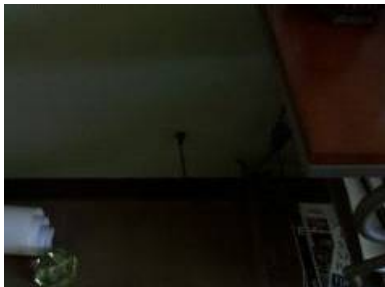
Keynote 617

Location:
Admin. - Office

Existing Condition: 4 power outlets, 1 data port.

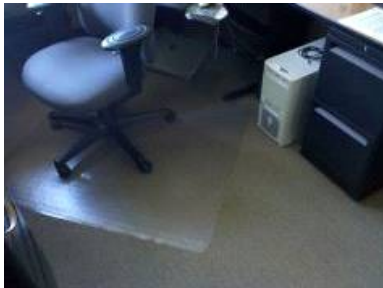
Keynote 620

14.23B - Floor Surface - Accessible route surfaces are not stable, firm and slip-resistant.

Existing Condition: Floor mat.

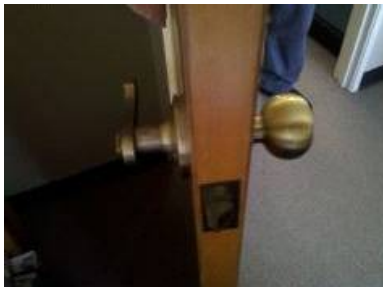
Keynote 623

11.11 - Single-Action Hardware - Handles, locks, and latches or other operative devices are not operable with one hand and without tight grasping, pinching, or twisting of the wrist. (U-shaped handles, levers, and push/pull type mechanisms are acceptable designs.)

Existing Condition: Door knob and twist-type locking mechanism.

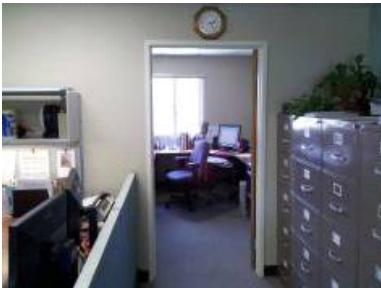
Keynote 624

Location:
Admin. - Office

11.17A - Recommendation: Providing Room/Space ID Sign - A sign designating the permanent room or space has not been provided.

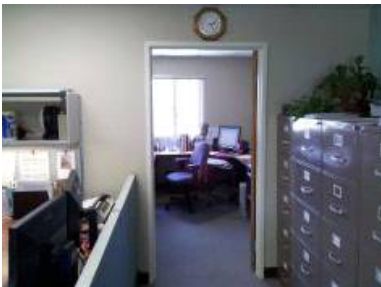
Keynote 625

Location:
Admin. - Office

Existing Condition: Door jamb at 79" AFF.

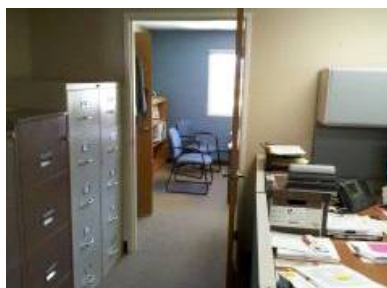
Keynote 626

Location:
Admin. - Office

11.17A - Recommendation: Providing Room/Space ID Sign - A sign designating the permanent room or space has not been provided.

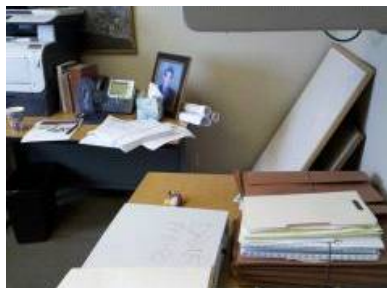
Keynote 627

Location:
Admin. - Office

Existing Condition: 2 power outlets, 1 data port.

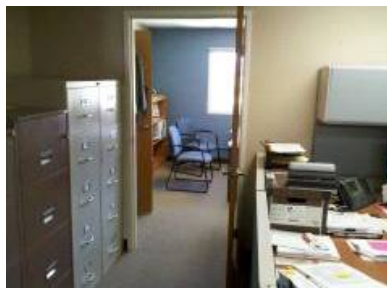
Keynote 628

11.06A - Door Maneuvering Space - Door that is not automatic or power-assisted does not have compliant maneuvering space relative to the direction of approach as shown in CBC Fig. 11B-26. (Approach // Side // Width // Depth) (Front // Pull // D + 24" * // 60") (Front // Push // D + 0" ** // 48") (Latch // Pull // D + 24" // 60") (Latch // Push // D + 24" // 44" ***) (Hinge // Pull // D + 36" // 60") (Hinge // Push // 54" **** // 44" *****) (* D + 18" at interior doors.) (** D + 12" if door has both a latch and a closer.) (*** 48" if door has closer.) (**** Measured from latch toward hinge.) (***** 48" if door has both a latch and a closer.)

Existing Condition: 2 1/2" pull side, non-fixed furniture.

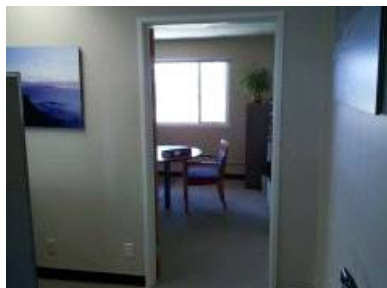
Keynote 630

Location:
Admin. - Office

11.17A - Recommendation: Providing Room/Space ID Sign - A sign designating the permanent room or space has not been provided.

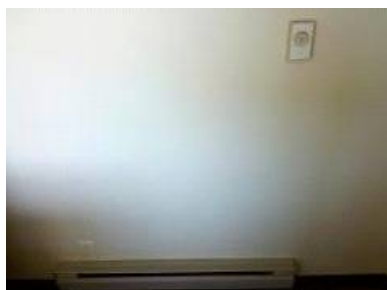
Keynote 631

Location:
Admin. - Office

Existing Condition: 3 power outlets.

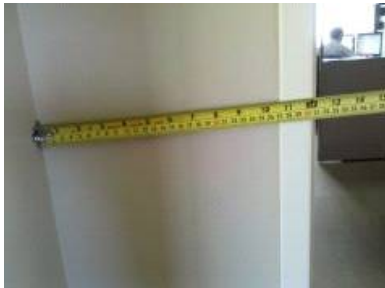
Keynote 633

11.06A - Door Maneuvering Space - Door that is not automatic or power-assisted does not have compliant maneuvering space relative to the direction of approach as shown in CBC Fig. 11B-26. (Approach // Side // Width // Depth) (Front // Pull // D + 24" * // 60") (Front // Push // D + 0" ** // 48") (Latch // Pull // D + 24" // 60") (Latch // Push // D + 24" // 44" ***) (Hinge // Pull // D + 36" // 60") (Hinge // Push // 54" **** // 44" *****) (* D + 18" at interior doors.) (** D + 12" if door has both a latch and a closer.) (***) 48" if door has both a latch and a closer.) (**** Measured from latch toward hinge.) (***** 48" if door has both a latch and a closer.)

Existing Condition: 12" pull side, wall.

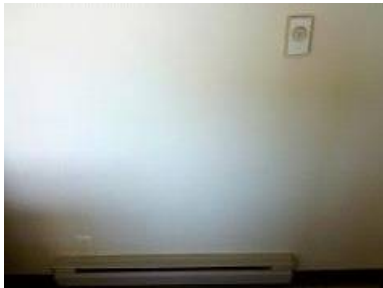
Keynote 634

14.35 - Controls - Operation - The controls are not accessible. (Accessible controls shall be operable with one hand, and without tight grasping, pinching, or twisting of the wrist, and the force to operate the controls shall be no greater than 5 lbs.)

Existing Condition: Twist-type thermostat.

031B - Replace Control - Replace control. Repair/refinish as required.

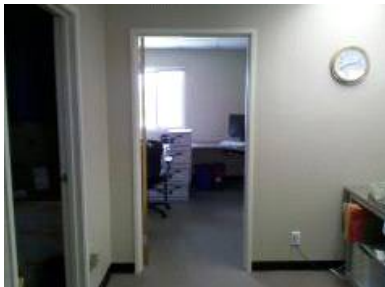
Keynote 639

11.17A - Recommendation: Providing Room/Space ID Sign - A sign designating the permanent room or space has not been provided.

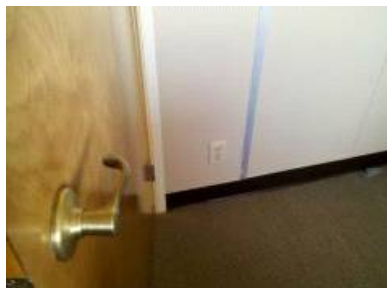
Keynote 641

Existing Condition: 6 power outlets, 3 data ports.

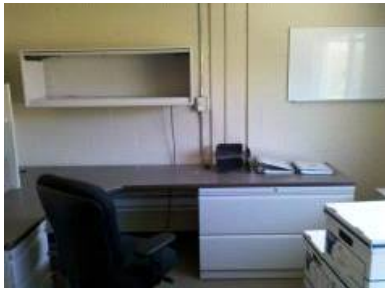
Keynote 642

Existing Condition: Twist-type thermostat.

031B - Replace Control - Replace control. Repair/refinish as required.

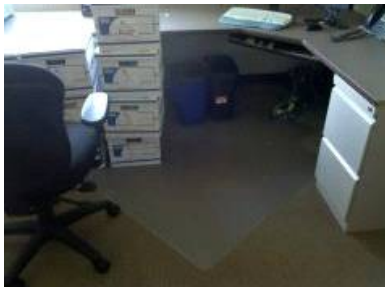
Keynote 643

Existing Condition: Floor mat.

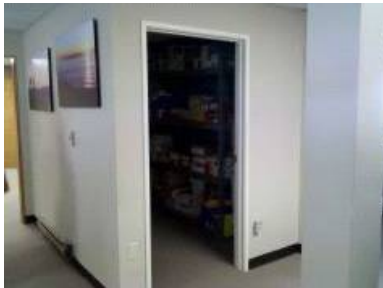
Keynote 644

11.17A - Recommendation: Providing Room/Space ID Sign - A sign designating the permanent room or space has not been provided.

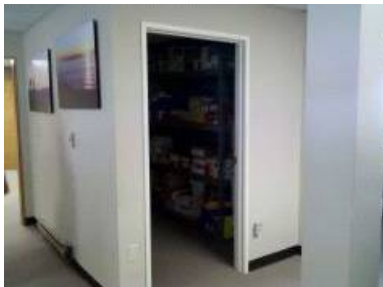
Keynote 645

Existing Condition: Door jamb at 79 1/4" AFF.

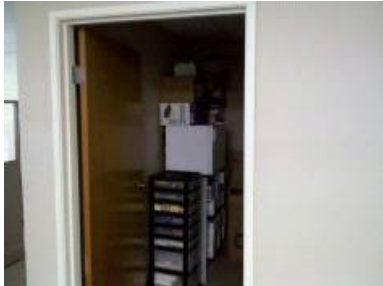
Keynote 646

11.06A - Door Maneuvering Space - Door that is not automatic or power-assisted does not have compliant maneuvering space relative to the direction of approach as shown in CBC Fig. 11B-26. (Approach // Side // Width // Depth) (Front // Pull // D + 24" * // 60") (Front // Push // D + 0" ** // 48") (Latch // Pull // D + 24" // 60") (Latch // Push // D + 24" // 44" ***) (Hinge // Pull // D + 36" // 60") (Hinge // Push // 54" **** // 44" *****) (* D + 18" at interior doors.) (** D + 12" if door has both a latch and a closer.) (***) 48" if door has closer.) (**** Measured from latch toward hinge.) (***** 48" if door has both a latch and a closer.)

Existing Condition: 40" deep landing at pull side, non-fixed furniture.

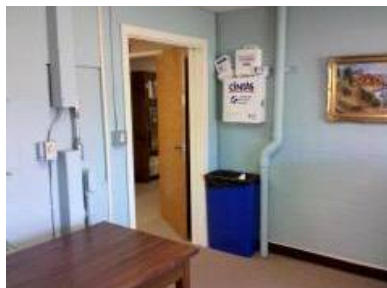
Keynote 648

Existing Condition: First aid kit at 66 1/2" AFF and infection control kit at 77 1/2" AFF.

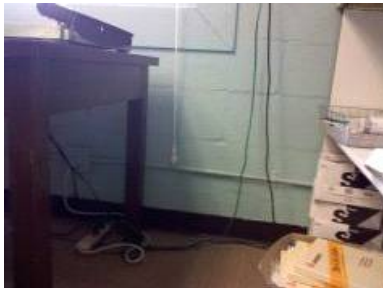
Keynote 649

Existing Condition: 2 power outlets at 11" AFF.

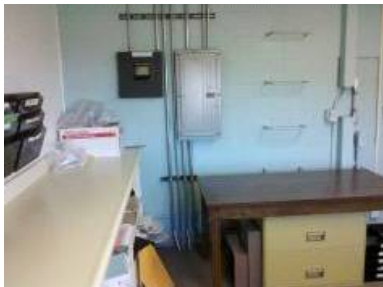
Keynote 650

Existing Condition: Phone at 61 1/2" AFF behind obstruction and alarm key pad at 64" AFF.

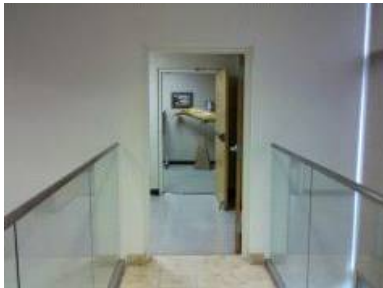
Keynote 652

Existing Condition: 61" AFF.

388D - Relocate Fire Extinguisher - Relocate existing fire extinguisher. Repair and refinish.

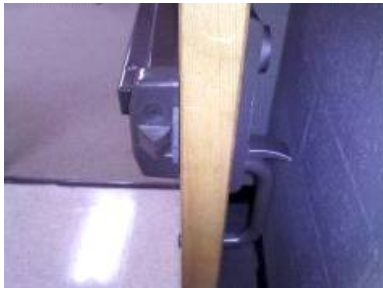
Keynote 654

Existing Condition: Thumb latch.

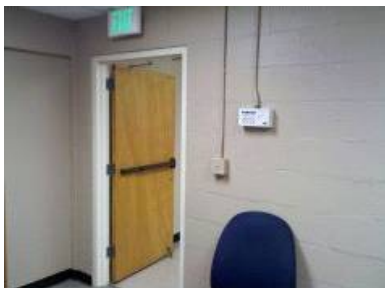
Keynote 656

11.13A - Door Operating Effort - The force required to operate door exceeds 5 lbs. (Fire doors may have up to 15 lbs to achieve positive latching).

Existing Condition: 10 LBF.

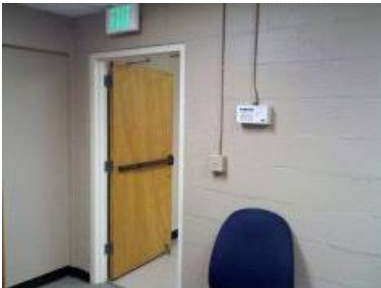
Keynote 658

Existing Condition: Door jamb at 77 1/2" AFF.

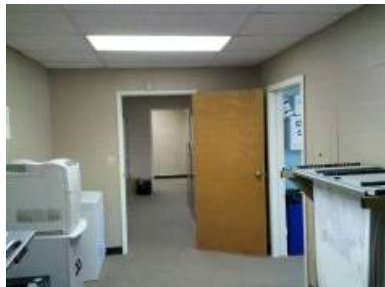
Keynote 661

11.11 - Single-Action Hardware - Handles, locks, and latches or other operative devices are not operable with one hand and without tight grasping, pinching, or twisting of the wrist. (U-shaped handles, levers, and push/pull type mechanisms are acceptable designs.)

Existing Condition: Door knob.

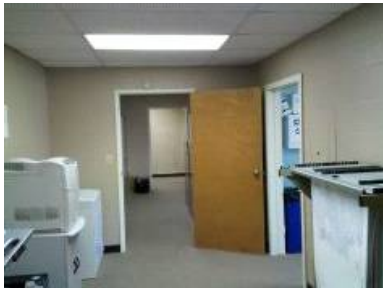
Keynote 662

Existing Condition: Door jamb at 79" AFF.

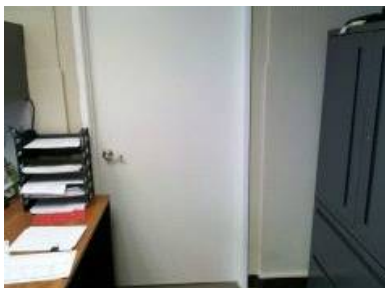
Keynote 664

11.17A - Recommendation: Providing Room/Space ID Sign - A sign designating the permanent room or space has not been provided.

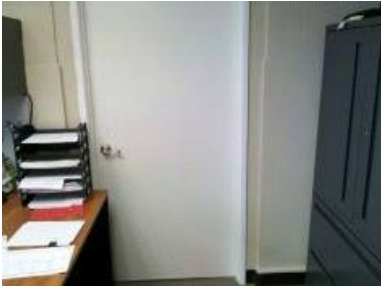
Keynote 665

11.06A - Door Maneuvering Space - Door that is not automatic or power-assisted does not have compliant maneuvering space relative to the direction of approach as shown in CBC Fig. 11B-26. (Approach // Side // Width // Depth) (Front // Pull // D + 24" * // 60") (Front // Push // D + 0" ** // 48") (Latch // Pull // D + 24" // 60") (Latch // Push // D + 24" // 44" ***) (Hinge // Pull // D + 36" // 60") (Hinge // Push // 54" **** // 44" *****) (* D + 18" at interior doors.) (** D + 12" if door has both a latch and a closer.) (***) 48" if door has closer.) (**** Measured from latch toward hinge.) (***** 48" if door has both a latch and a closer.)

Existing Condition: Non-fixed furniture encroaches door maneuvering space.

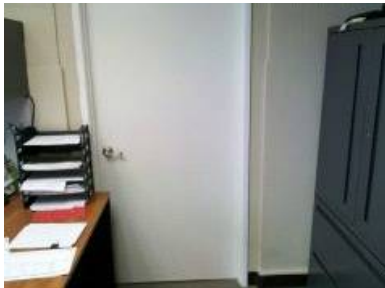
Keynote 666

Existing Condition: Door jamb at 78 3/8" AFF.

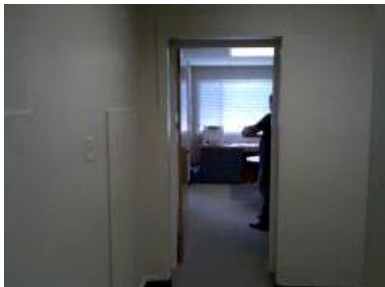
Keynote 667

Existing Condition: Door jamb at 77" AFF.

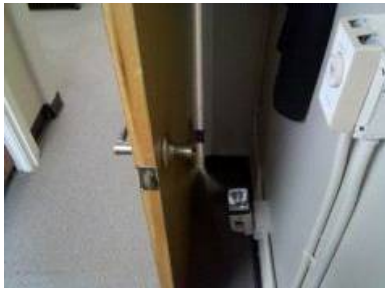
Keynote 668

11.11 - Single-Action Hardware - Handles, locks, and latches or other operative devices are not operable with one hand and without tight grasping, pinching, or twisting of the wrist. (U-shaped handles, levers, and push/pull type mechanisms are acceptable designs.)

Existing Condition: Twist-type lock.

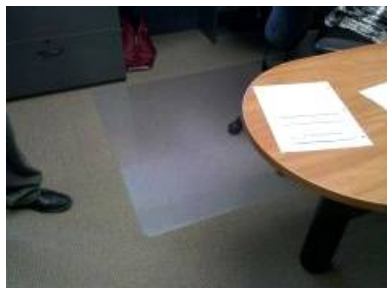
Keynote 671

14.23B - Floor Surface - Accessible route surfaces are not stable, firm and slip-resistant.

Existing Condition: Floor mat.

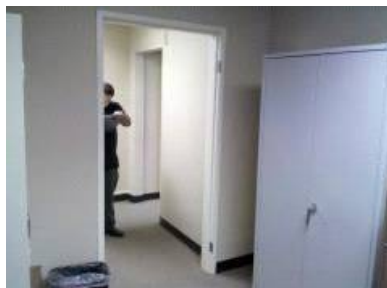
Keynote 673

14.31 - Head Room - Clear head room is at less than 80" within the pedestrian circulation area, including the accessible route of travel.

Existing Condition: Door jamb at 79" AFF.

Additional Comments: Remove door jamb. Patch and repair to match existing.

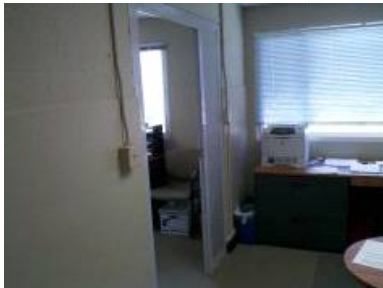
Keynote 674

Existing Condition: Door jamb at 76 3/4" AFF.

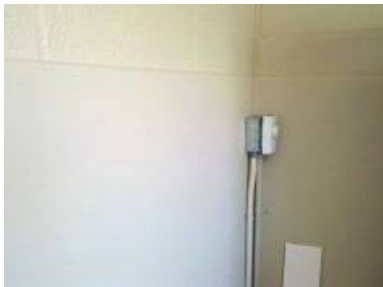
Keynote 675

Existing Condition: Twist-type thermostat.

031B - Replace Control - Replace control. Repair/refinish as required.

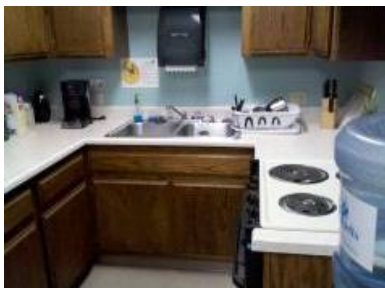
Keynote 680

Existing Condition: Knee space not provided.

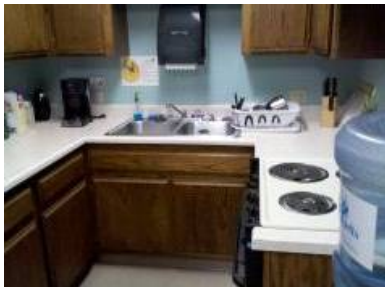
Keynote 681

Existing Condition: Non-compliant faucet controls.

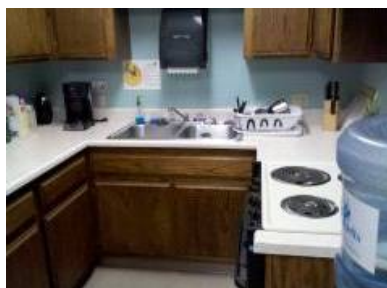
Keynote 682

Existing Condition: 51" AFF.

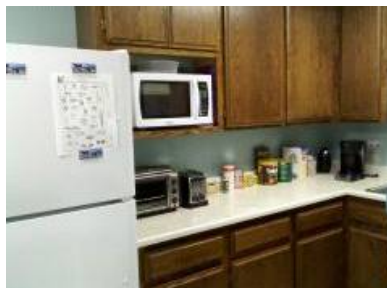
Keynote 683

Existing Condition: Microwave at 64 1/2" AFF.

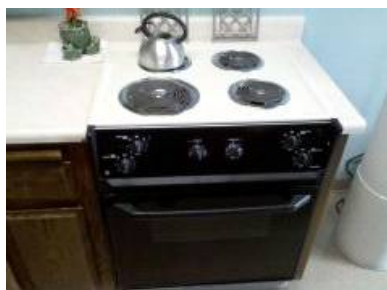
Keynote 684

Existing Condition: Non-compliant controls at stove.

031B - Replace Control - Replace control. Repair/refinish as required.

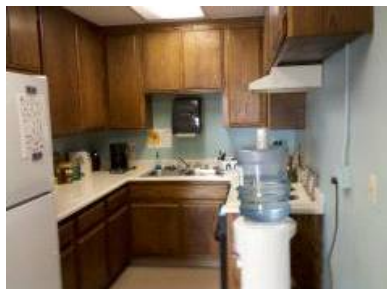
Keynote 685

Existing Condition: Upper cabinets at 72" AFF.

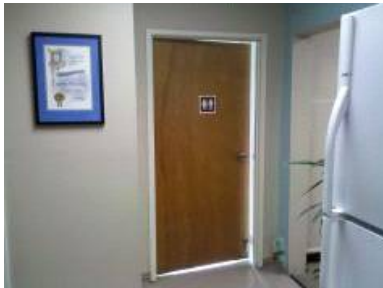
Keynote 686

14.31 - Head Room - Clear head room is at less than 80" within the pedestrian circulation area, including the accessible route of travel.

Existing Condition: Door jamb at 79 1/2" AFF.

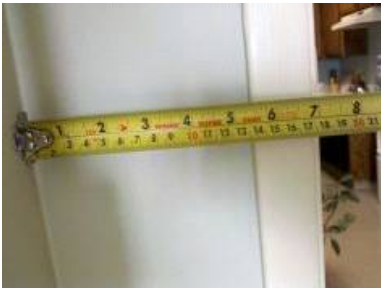
16.09A - Door Maneuvering Space - Door that is not automatic or power-assisted does not have compliant maneuvering space relative to the direction of approach as shown in CBC Fig. 11B-26. (Approach // Side // Width // Depth) (Front // Pull // D + 24" * // 60") (Front // Push // D + 0" ** // 48") (Latch // Pull // D + 24" // 60") (Latch // Push // D + 24" // 44" ***) (Hinge // Pull // D + 36" // 60") (Hinge // Push // 54" **** // 44" *****) (* D + 18" at interior doors.) (** D + 12" if door has both a latch and a closer.) (***) 48" if door has closer.) (**** Measured from latch toward hinge.) (***** 48" if door has both a latch and a closer.)

Existing Condition: 7" to CMU wall at pull side, & 47" landing at pull side.
